Panama City - Millville Area  
Finding of Necessity for Redevelopment

Prepared for:  
The City of Panama City  
July 2002

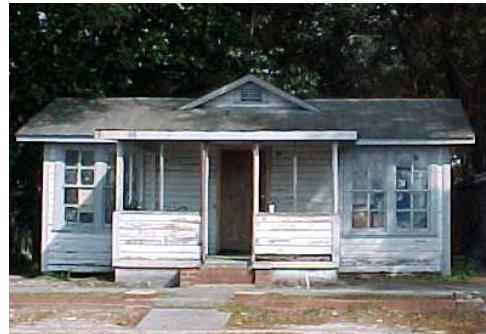
Fieldwork conducted by RMPK confirmed the existence of these conditions in the Millville study area. Criteria not only included the physical condition of structures, but also local roadway, alley, and sidewalk conditions and the condition of vacant parcels and buildings that may be subject to further deterioration. Virtually the entire study area displayed characteristics of deterioration including local road surfaces, dirt alleyways, broken concrete sidewalks and the accumulation of trash and debris. This is not only a strong indication of the physical condition of the public right-of-way and private properties in the study area, it reflects the declining economic conditions in the area representing a lack of investment in property upkeep and maintenance.

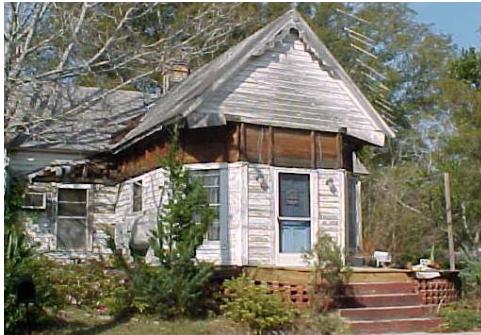
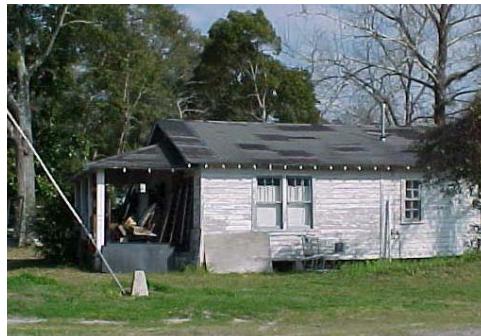
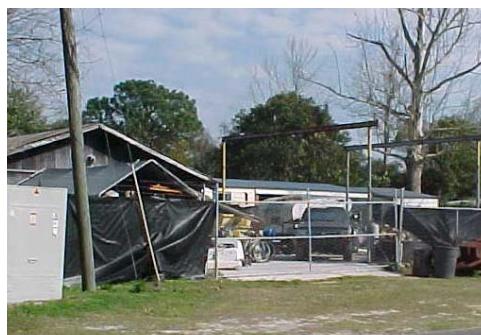
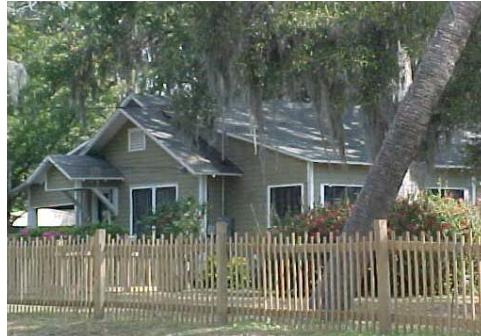
Older buildings are often more costly to maintain. Combined with the potential for lower market demand, the likelihood is increased that deterio-

The combination of older building stock with deteriorating conditions results in other negative factors in the community, including:

- Depressed property values, resulting in lower local tax revenues.
- Increased fire hazard potential.
- Increased code enforcement demands.
- Concentration of low-income groups and marginal businesses with decreased potential for investment to reverse the blighting conditions.
- Creation of an environment that is attractive to transients and conducive to criminal activity.
- Low potential for rents promotes the conversion of single-family homes to multi-family units, often as single room occupancy units, resulting in a decrease in long-term homeowners.
- Creation of a poor market environment, where existing businesses relocate to other, more stable areas, and new businesses do not replace them.

In summary, the concentration of old and deteriorating buildings within the study area is a blighting condition. It discourages investment in development and redevelopment, ultimately decreasing the property values and tax revenues for the surrounding area.

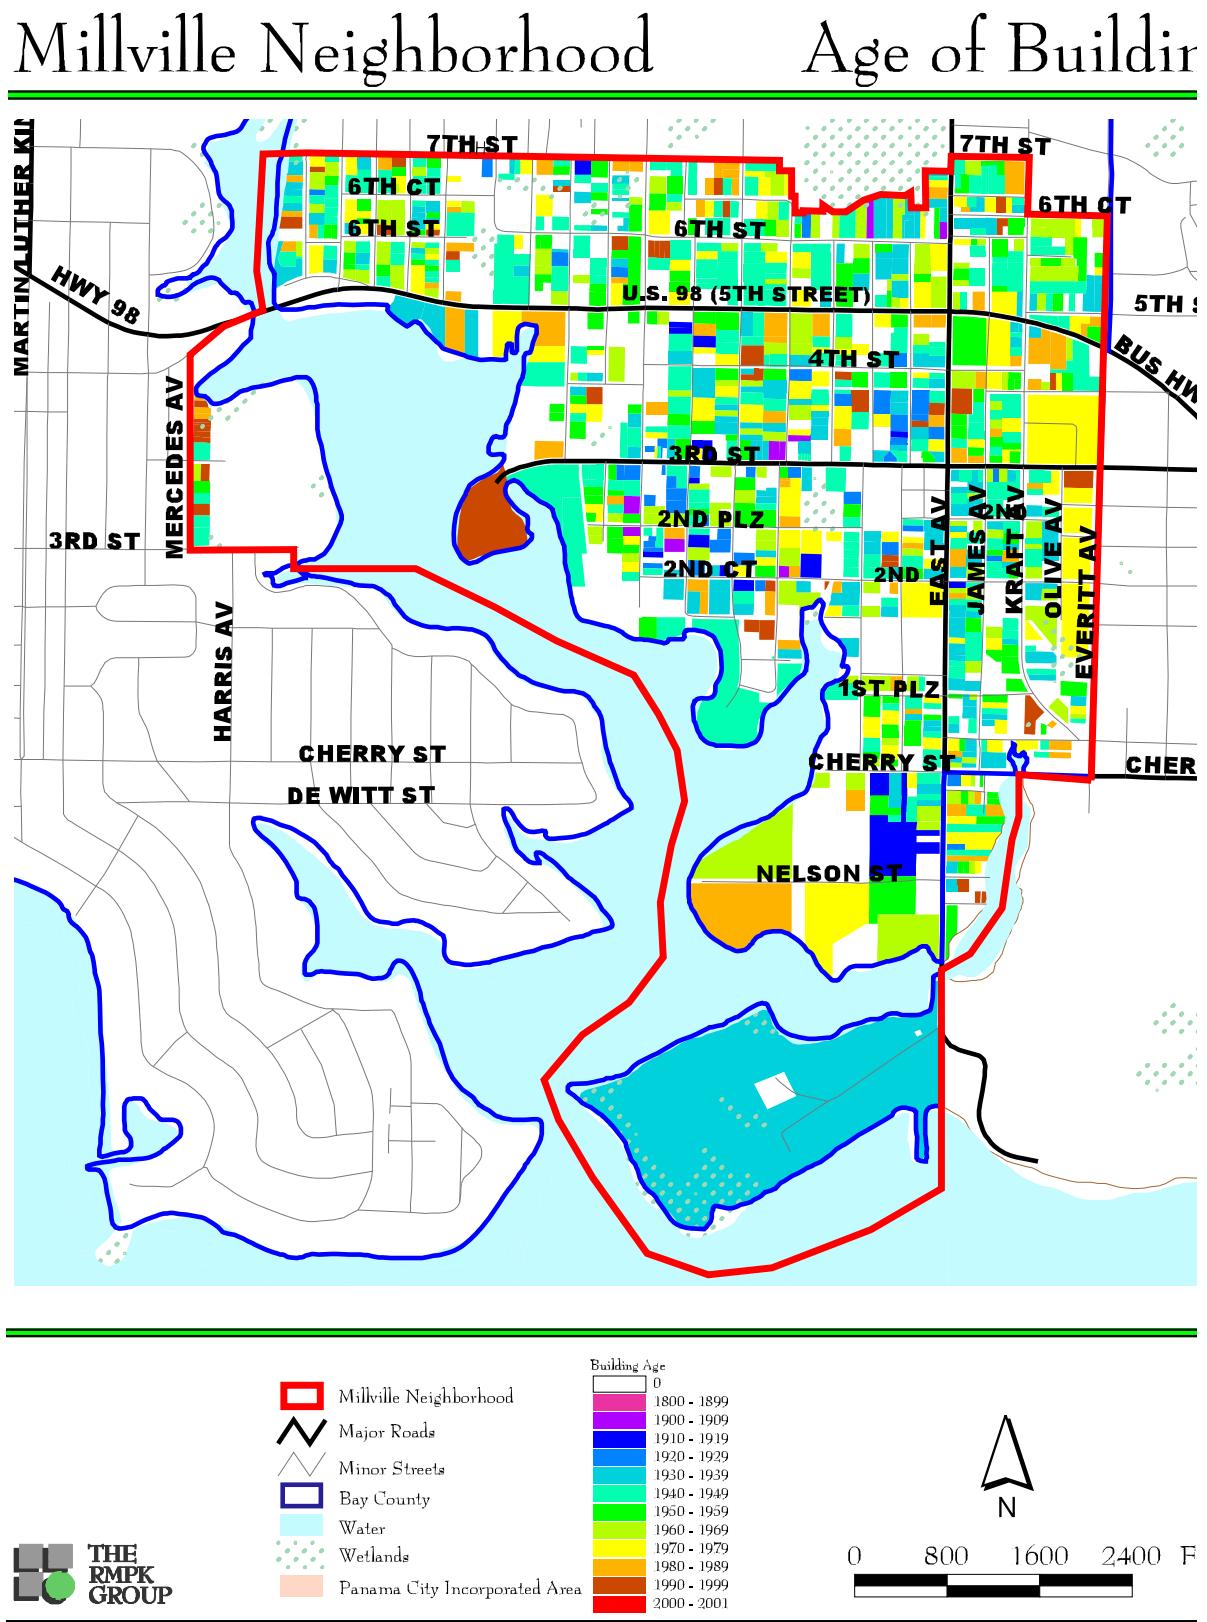
Figure 5 - Age of Buildings

Another indication of the building stock quality in an area can be the relative age of the buildings. Aging buildings typically require increased maintenance and repair. In addition, the interior space, exterior appearance, and functional aspects of older buildings may be obsolete for modern market demands. When market demand declines, lease revenues decline, and investment in upkeep or enhancement may suffer.

Age of the primary structure of a site is recorded by the Bay County Property Appraiser's Office, but is not available for all sites in the study area. For those sites where data is available, the average building age is fifty-six years.

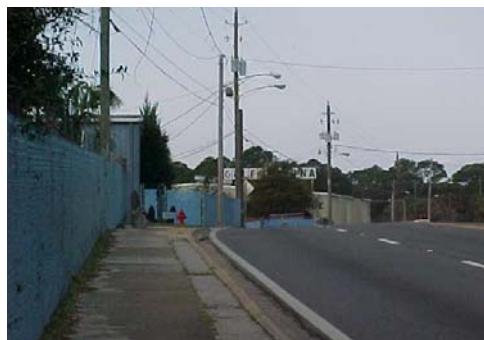
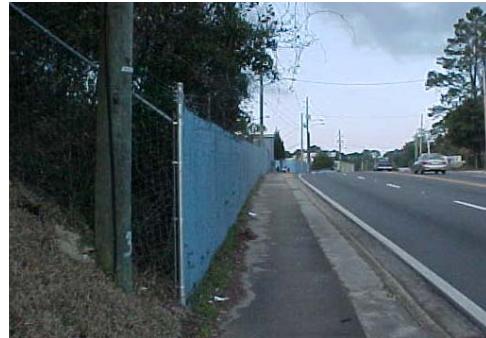
The existing sidewalk system along U.S. 98 is complete, however the sidewalk is immediately adjacent to the curb and travel lane, affording no protection or buffering from traffic movement. Additionally, multiple driveways that often are excessively wide introduce many potential sources of conflict between motorists and pedestrians.

Therefore, while the condition of the existing

transportation network may be adequate, the sidewalk system may be considered a contributing factor in the conditions of blight.

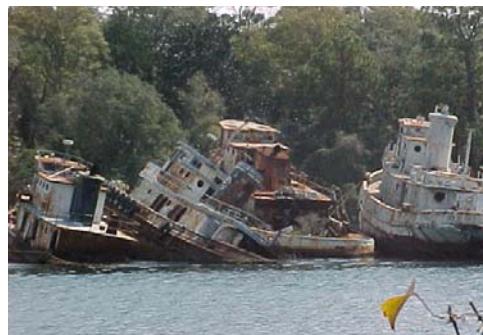
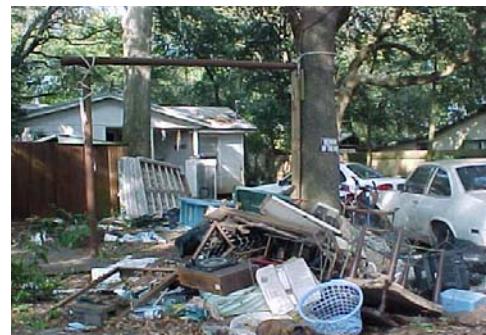
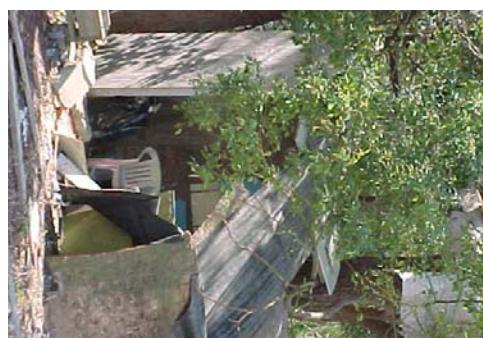
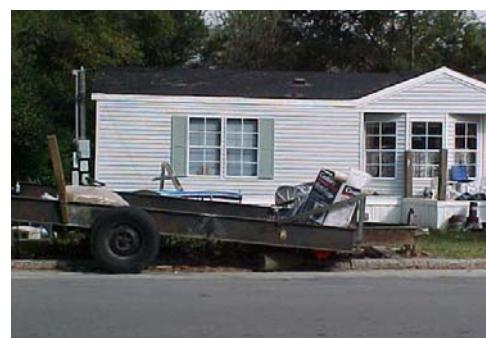
Several areas of Millville have unsanitary and unsafe conditions. As seen in the photographs below: Dilapidated structures, outside storage, litter, and debris are external signs of property neglect. There is little chance of revitalizing this community if the unsanitary and unsafe conditions are not addressed through the redevelopment process. This situation is compounded by the fact that there is insufficient code enforcement in the Millville area.

In addition, several commercial and industrial properties utilize outside storage of equipment and machinery causing unsafe conditions especially for children who often play nearby in adjacent residential areas.

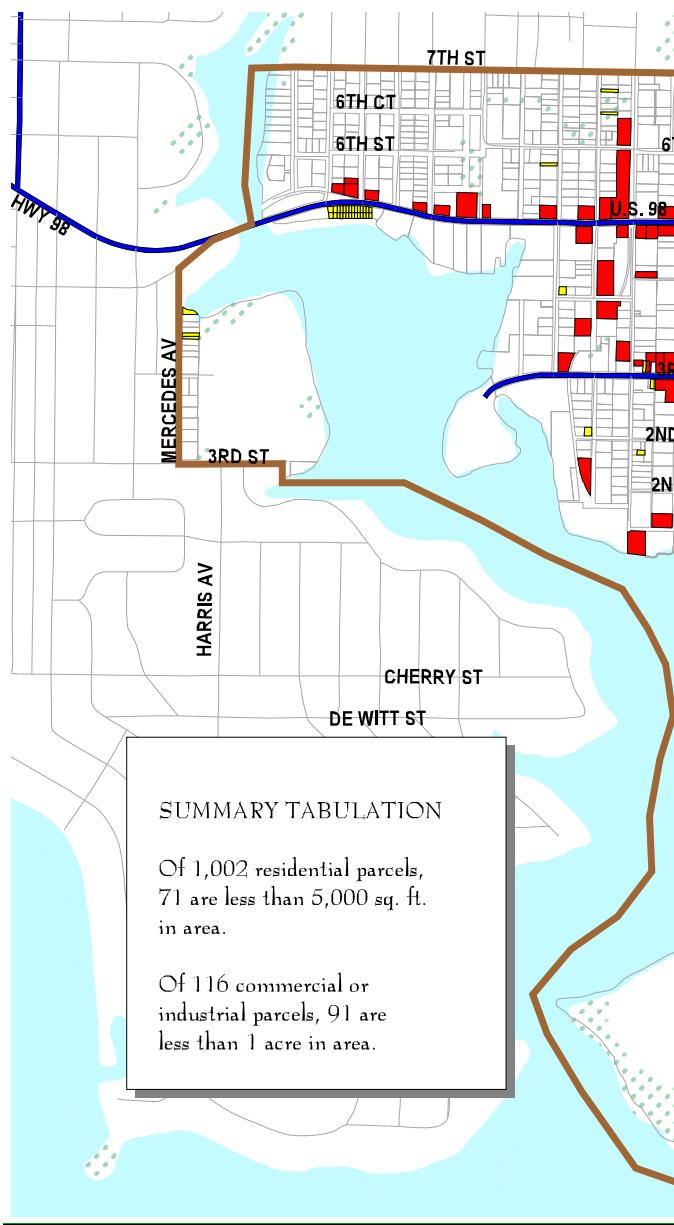
Figure 6 - Inadequate Parcel Size

Figure 6 identifies residential properties less than 5,000 square feet and commercial properties less than one acre, which are considered minimum parcel sizes for development of property in these land use categories. Of the 116 commercial properties in the study area, 91 (about 80% of the total) are less than one acre in size.

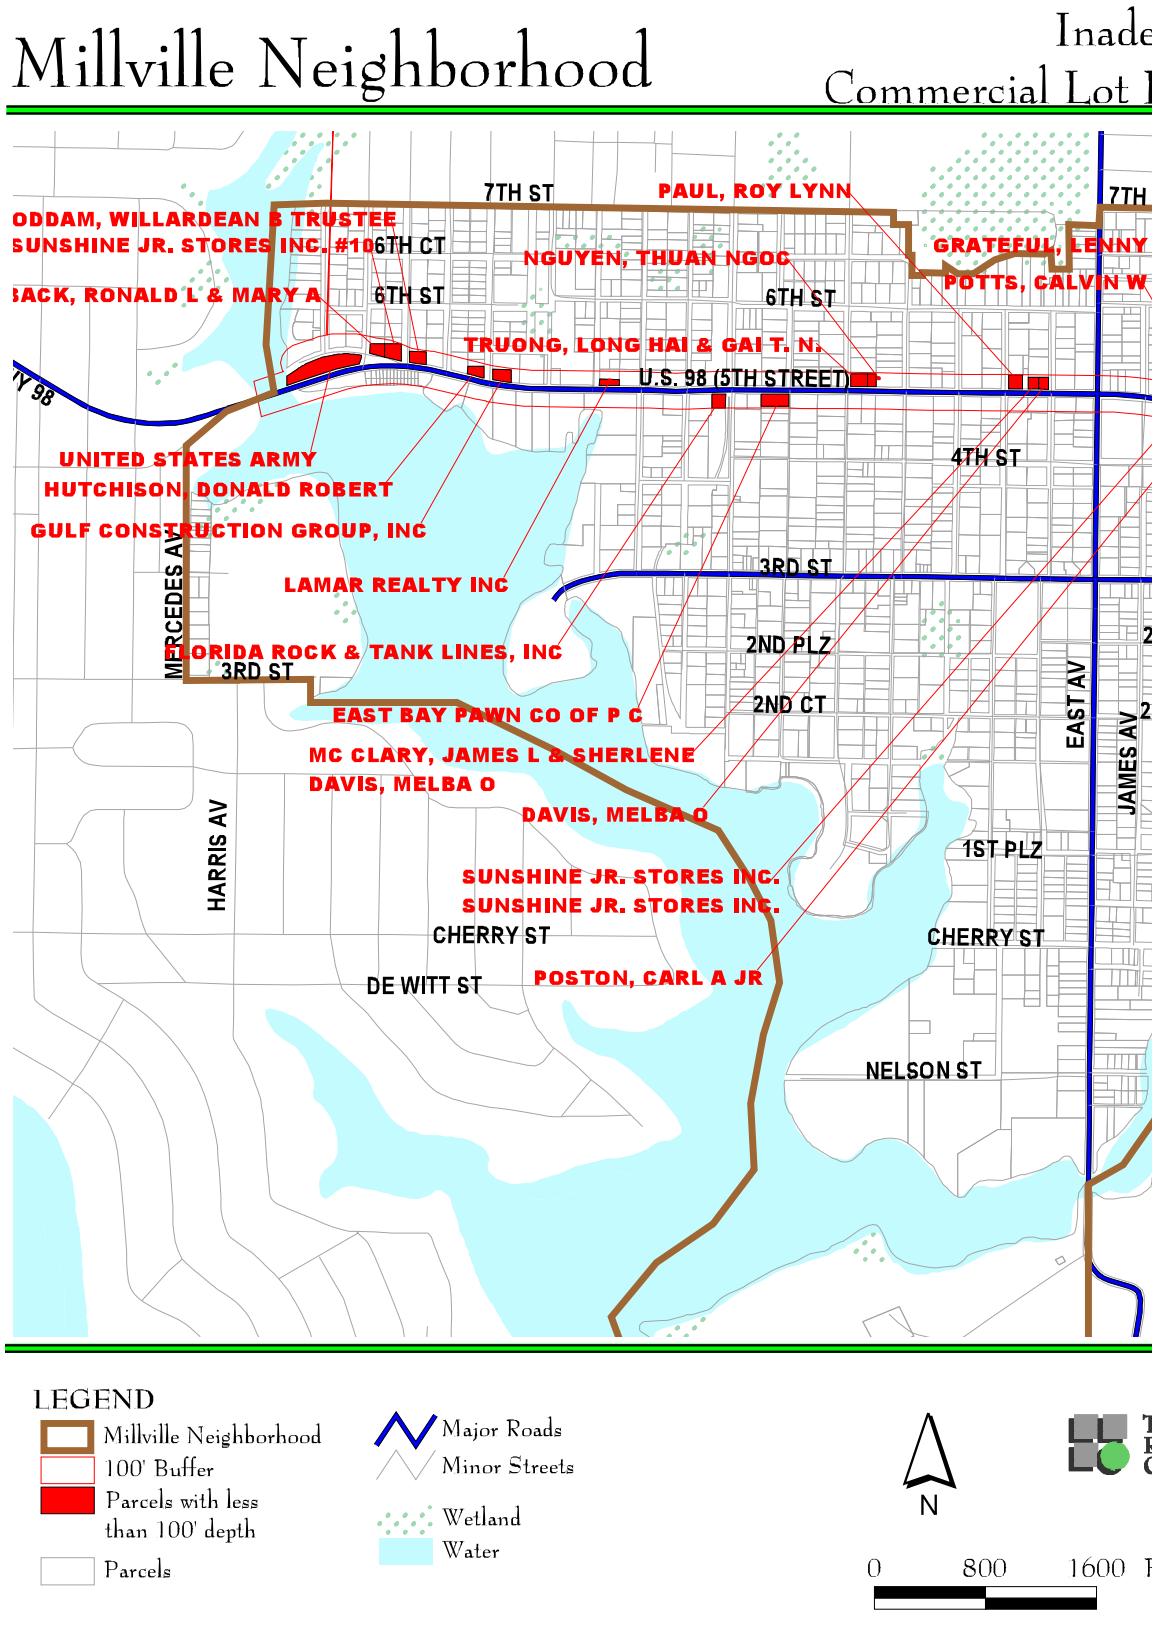
Figure 7 - Inadequate Commercial Lot Depth

Many of the properties located on U.S. 98 in the study area are facing potential economic liabilities due to lot size inadequacies. Figure 7 identifies the properties located on this road section with 100 feet or less of depth from the present right-of-way line. Of the 121 parcels fronting the highway, 19 were found to be less than 100 feet in depth. In many instances the lack of depth has caused overflow parking and loading zone conflicts with adjacent residential properties.

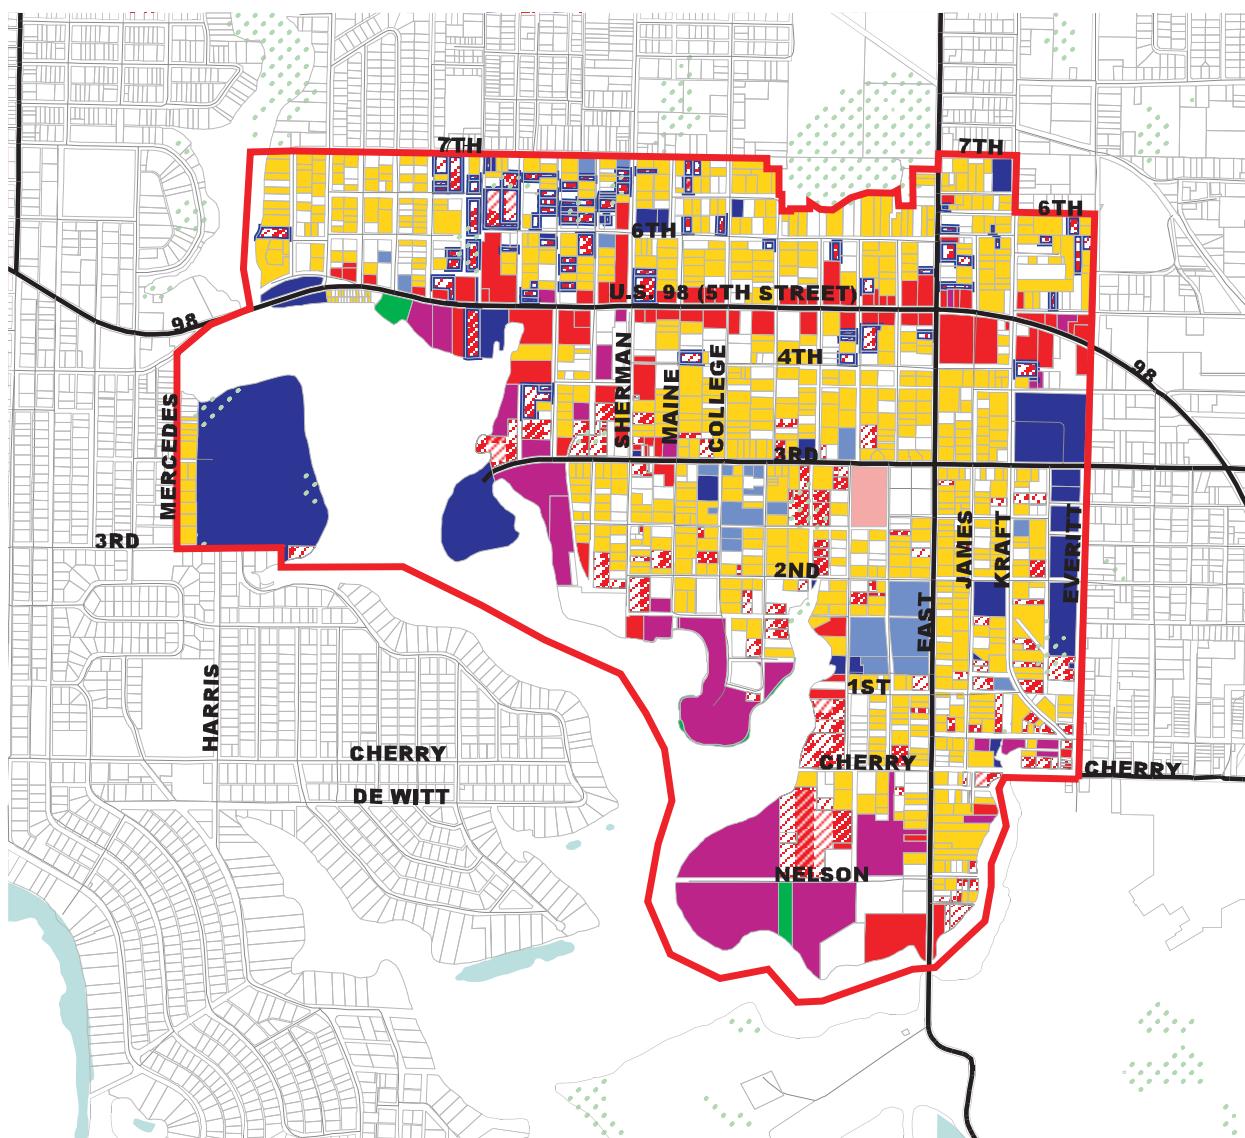
Figure 8 - Residential Owner Occupancy

Data obtained from the Bay County Property Appraiser suggests a high proportion of rental property in the study area. Of the 1,421 properties in Millville, 726 (51%) are owner-occupied. Properties that are not owner-occupied total 695 (49%). When occupancy of residential parcels alone is analyzed, the owner-occupancy rate climbs to 72%, with 28% being not owner-occupied. Rental property located in a declining real estate market perpetuates the cycle of deteriorating conditions due to the inherent lack of motivation and finances to maintain property. Figure 8 shows a residential occupancy analysis.

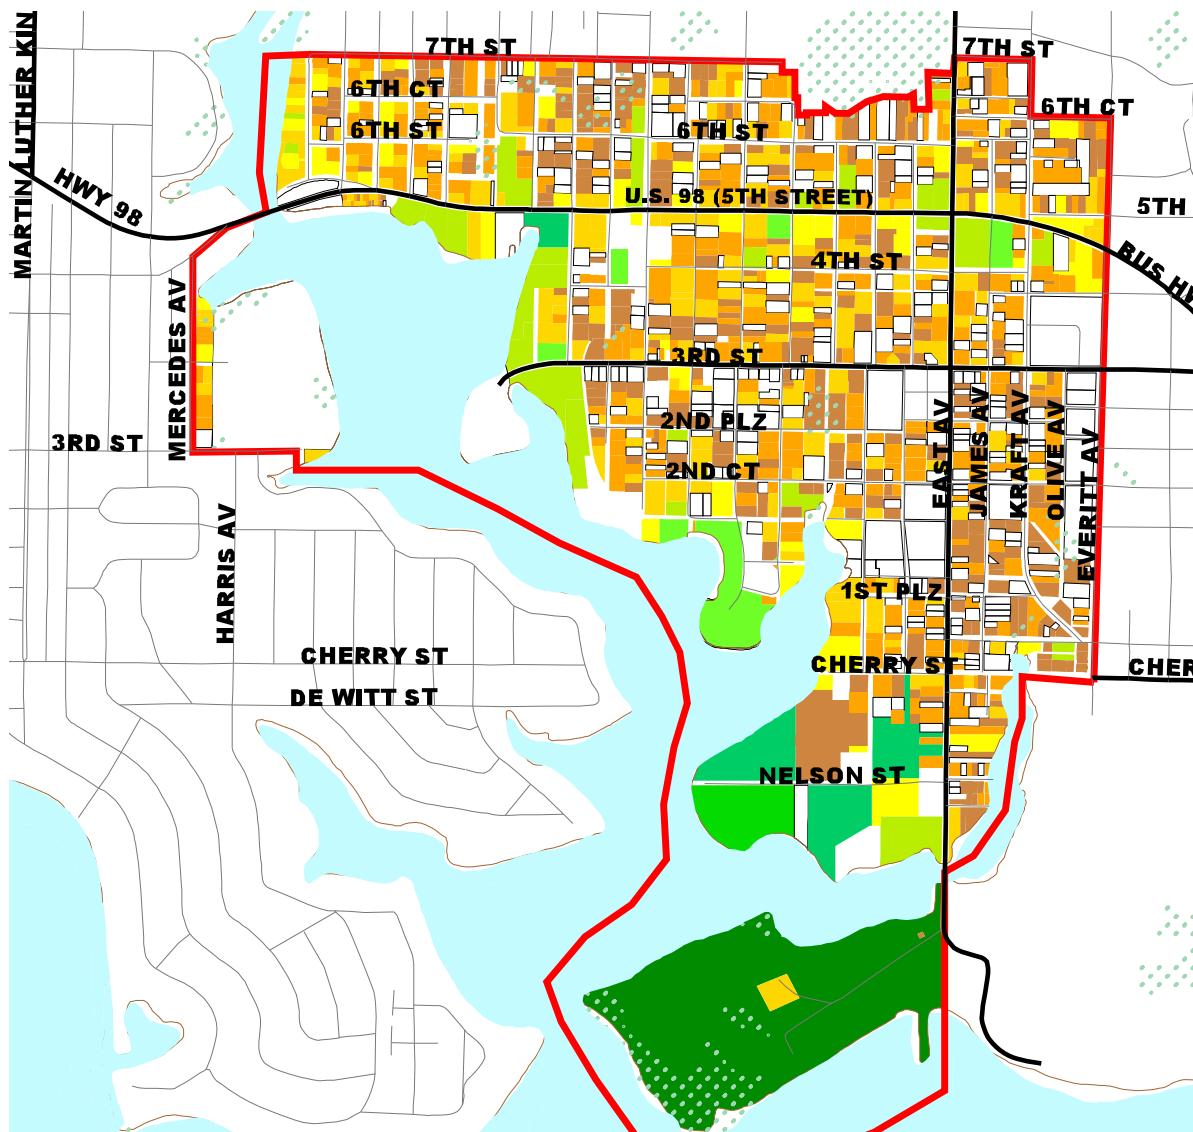
Figure 9 - Taxable Value

The combination of small lots, age of buildings, number of substandard buildings, and the vacancy and physical condition of commercial properties is reflected in low property values for the study area. Figure 9 shows taxable property values in Millville. The predominance of residential property with taxable value less than \$25,000 indicates a very weak tax base.

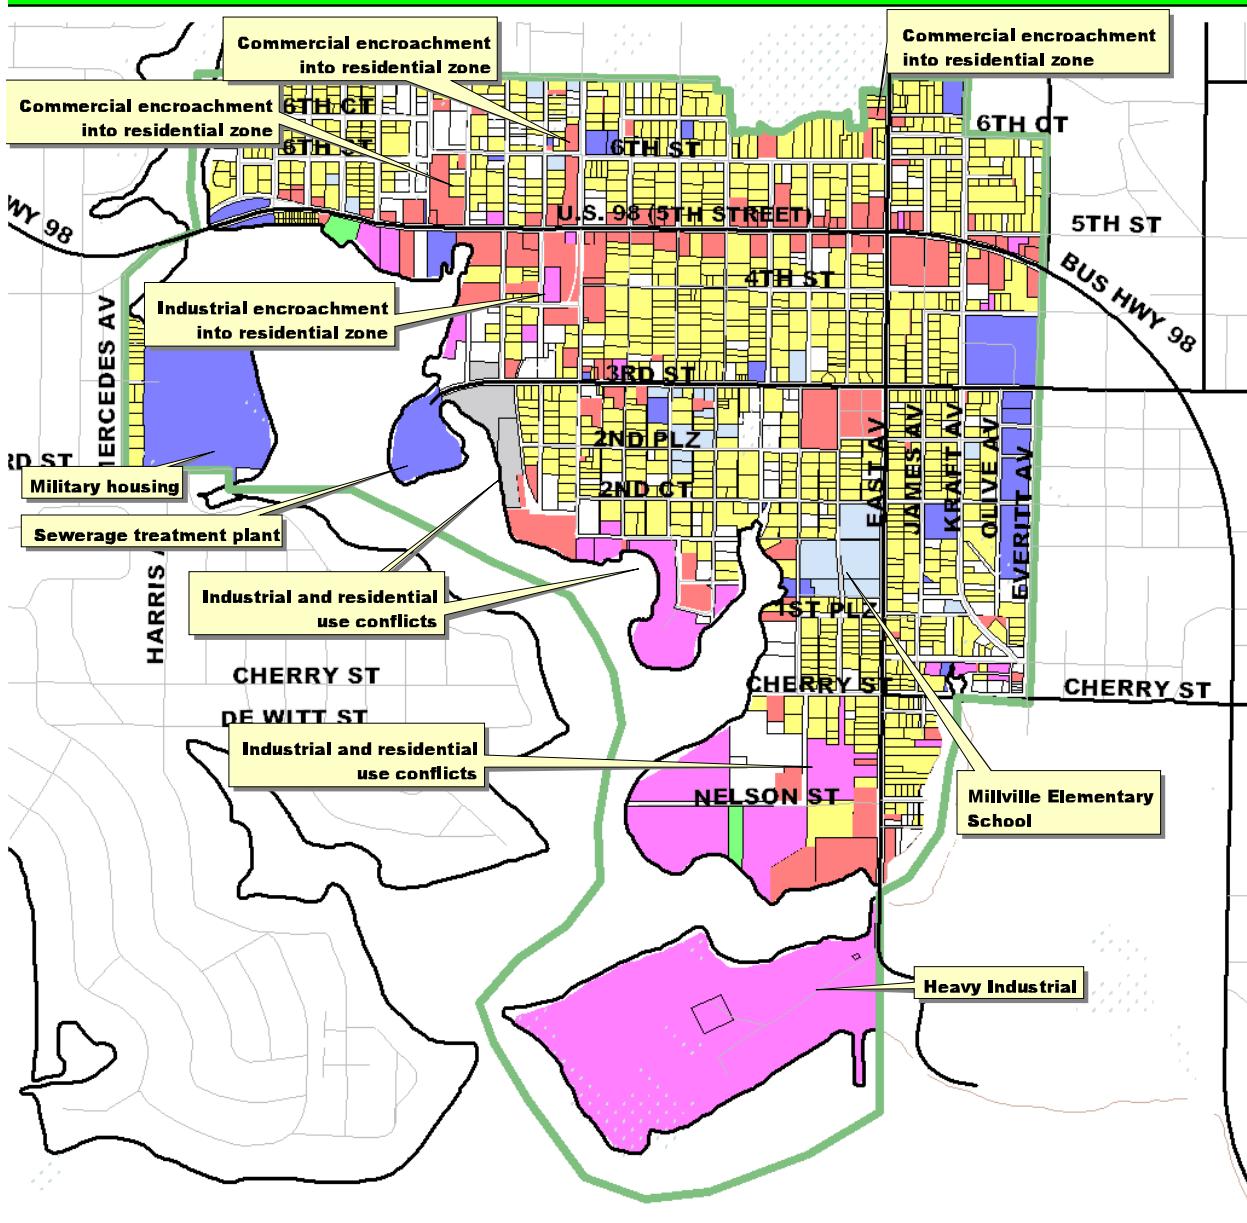
Figure 10 - Land Use Conflicts

Figure 10 and the following photos depict a composite of conflicting land uses that are detrimental to the conditions of the local real estate market and to the health of the tax base. A severe land use conflict exists between commercial, industrial, and residential land uses along U.S. 98 and on the Watson Bayou shoreline. The condition exists where older commercial properties are located on small lots with little or no buffer between the commercial use and the adjacent residential use. In other areas, heavy commercial and industrial uses surround small pockets of residential use or intrude into predominantly residential areas. The decision to build a sewage treatment plant in the Bayou area has also contributed significantly to the problem of conflicting land use.

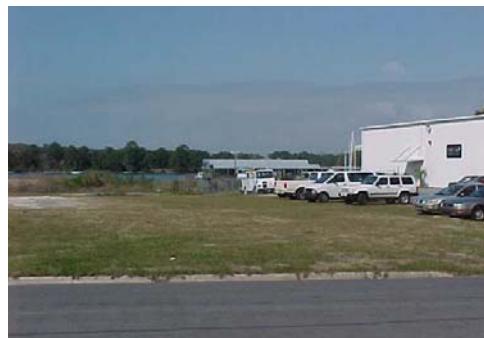
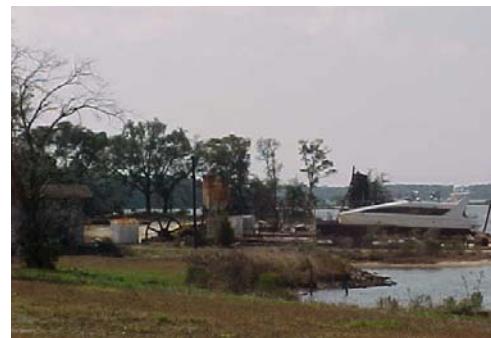
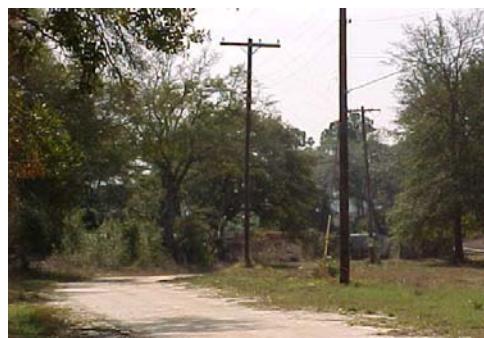
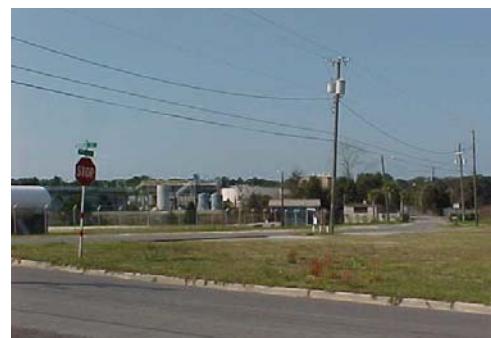
Figure 11 - Vacancy Analysis

- Vacant land is an obvious sign of economic disuse. Vacant properties in the study area are a challenge to be developed at their highest and best use because of the area's inability to succeed in competitive market conditions given the obstacles to redevelopment described in this study. Figure 11 shows the 206 vacant parcels in the Millville neighborhood, out of a total of 1,421. Approximately 14% of the properties (14% of the acreage as well) in Millville are vacant.
